Plaque Accumulation on Exposed Titanium Surfaces and Peri-implant Tissue Behavior. A Preliminary 1-Year Clinical Study

Purpose: The aim of this study was to evaluate plaque accumulation and peri-implant tissue response adjacent to machined and dual acid-etched (DAE) titanium implant surfaces. **Materials and Methods:** Two types of implants were used—control implants with a DAE surface in their apical portion and a machined coronal part, and test implants with a DAE surface throughout their entire length. A total of 10 sets of implants were placed in the posterior quadrants of eight patients, with at least 2 implants (1 control and 1 test implant) placed in each site. Machined healing abutments were placed on the control implants and DAE-surfaced healing abutments on the test implants. Plaque Index and bleeding on probing (BOP) were recorded together with histologic and microbiologic analyses of the peri-implant tissues. The healing abutments underwent a scanning electron microscope scan at 5 months postsurgery. Standardized radiographs were also taken at the time of implant placement and 3, 6, and 12 months postsurgery. **Results:** DAE surfaces accumulated more plaque than machi

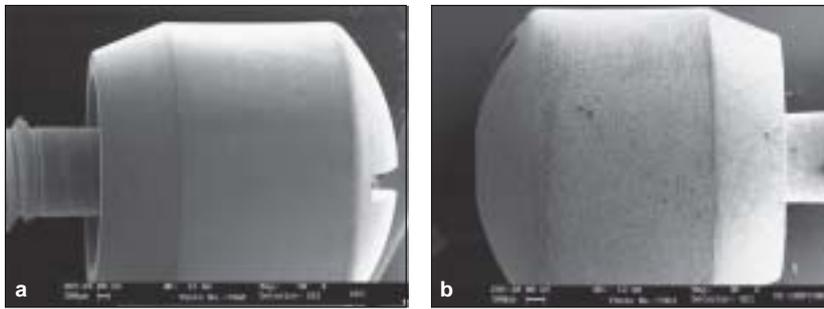
Figs 1a and 1b SEM photograph of (a) a machined abutment and (b) a DAE abutment; magnification $\times 50$.

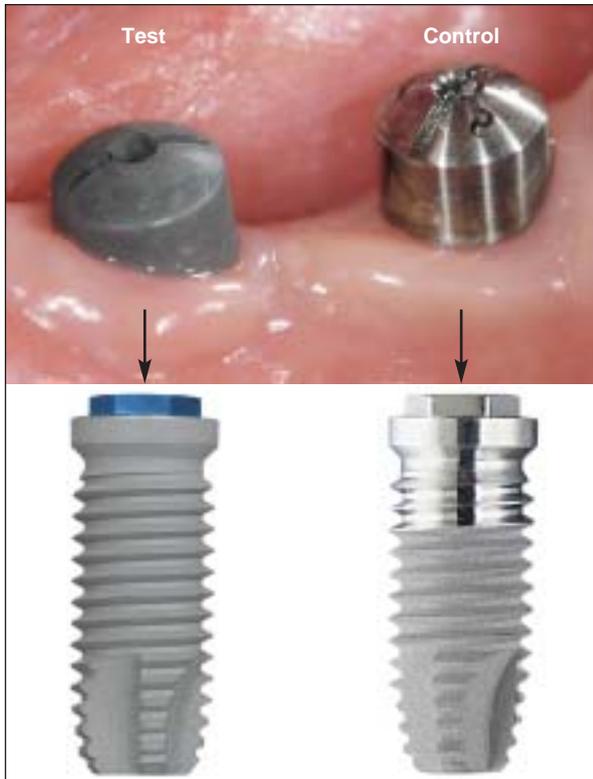
Fig 2 The machined healing abutments were connected to the Osseotite implants (control, *right*); the modified (DAE) surfaced healing abutments were connected to the FOSS implants (test, *left*).

Osseotite and FOSS implants were used in this study. A minor and shorter part of the study involved the use of healing abutments with two different types of surfaces—standard machined ($Ra = 0.0263 \pm 0.0036$) (Fig 1a) and DAE-surfaced ($Ra = 0.489 \pm 0.079$). The latter were custom made by Biomet 3i for this study (Fig 1b). The machined healing abutments were connected to the Osseotite implants (control) and the DAE surfaced healing abutments to the FOSS implants (test) (Fig 2).

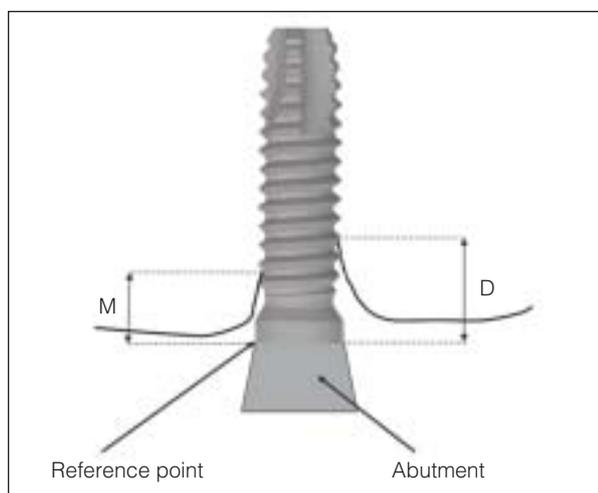
Fig 3 Interproximal crestal bone loss was measured from the implant-abutment junction to the most coronal bone level on the mesial (M) and distal (D) aspects of each implant.

Radiographic Analysis of Interproximal Bone Levels

using the registration of the healing abutments' positions. After insertion of the provisional prostheses (at 6 months and at 1 year), the subsequent radiographs were performed on the base of the prosthesis position. All of the radiographs were made using fast speed film (Ultra-Speed Kodak, Eastman Kodak). The threads on both sides of the implants were clearly seen in all of the radiographs. The implant-abutment interface was used as the reference point for interproximal bone level measurements.²² Bone resorption over the length of the study was assessed from these reference points to the most coronal bone at the mesial and distal aspects of each implant, that is the DIB was measured mesially and distally (Fig 3). A blinded radiologist who was not otherwise involved in the study performed the radiographic measurements using a standard diaphanoscope and magnifying lens.²² The measurements were repeated twice to minimize recording errors.

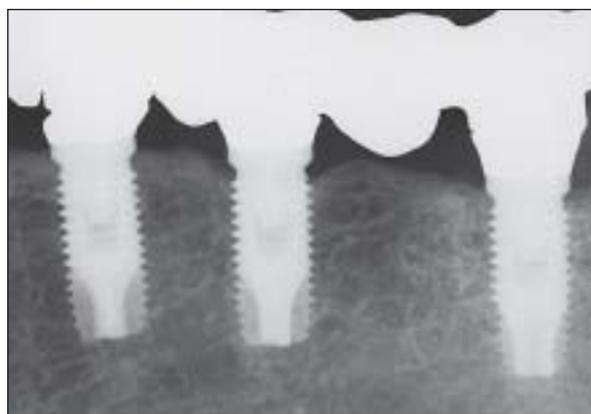
Fig 4 Periapical radiograph taken 1 year post-implant placement. The FOSS implants are mesial and distal to the Osseotite implant in the middle. Bone loss was noted to be at the level of the first thread for the Osseotite implant and 1 to 2 mm more coronal on the FOSS implants.

At 6 months, a significant difference in bone loss between the two implant surface types was noted ($P < .0146$). At 1 year post-implant placement, the difference in bone resorption between the test and control implants was also significant ($P < .0174$) (Fig 4).

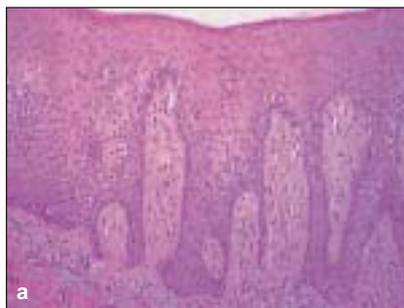
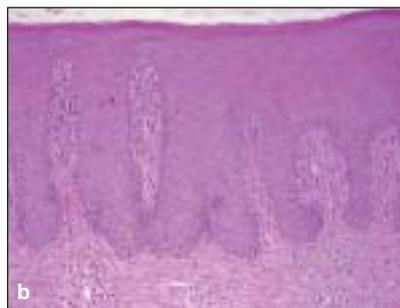
Figs 5a and 5b Section of a biopsy specimen from peri-implant mucosa surrounding (a) a machined healing abutment and (b) a modified (DAE) healing abutment at 3 months.

No differences were found relative to the two healing abutment surface treatments in the 10 clinical cases histologically analyzed (Figs 5a and 5b). In all patients, the histologic findings were similar: The samples were composed of a pluristratified squamous epithelial tissue with a fibrous stroma below the basement membrane. Granulation tissue with a poor inflammatory infiltrate was also noted. This was thought to be consistent with normal healing.

No differences were noticed in cellular composition or in inflammatory infiltrate of the tissues surrounding the two different surfaces.

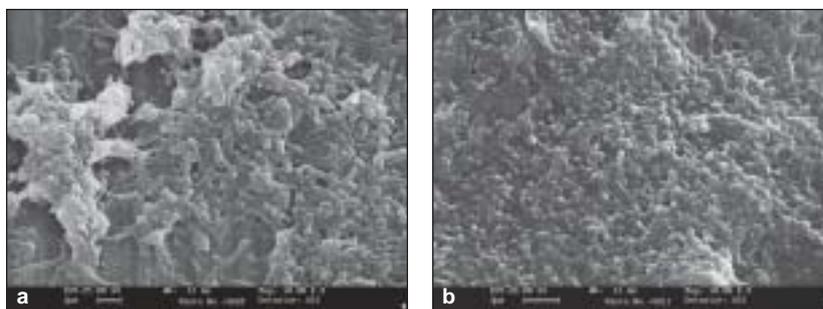
Figs 6a and 6b SEM photographs of (a) a machined abutment and (b) a DAE abutment removed from the same patient. Some areas free from plaque are still visible on the machined abutment. There are more accumulations of plaque on the DAE abutment, which is completely covered with plaque; magnification $\times 10,000$.

The abutment analysis with the SEM confirmed what the Plaque Index and the microbiologic analysis had already demonstrated. For the DAE surface healing abutments, plaque was present in greater quantities than visualized on the machined healing abutment surfaces (Figs 6a and 6b).
